# Access Compliance Report Public Rights-of-Way (Curb Ramps)

Main Street: GALANTE\_ST Cross Street: RISILLA\_ST Location: NW

ADA ID: RPRK211119132200 Ramp Type: Type 4 - Parallel Initial Pass/Fail: Fail Overall Compliance: No Severity Score: 5

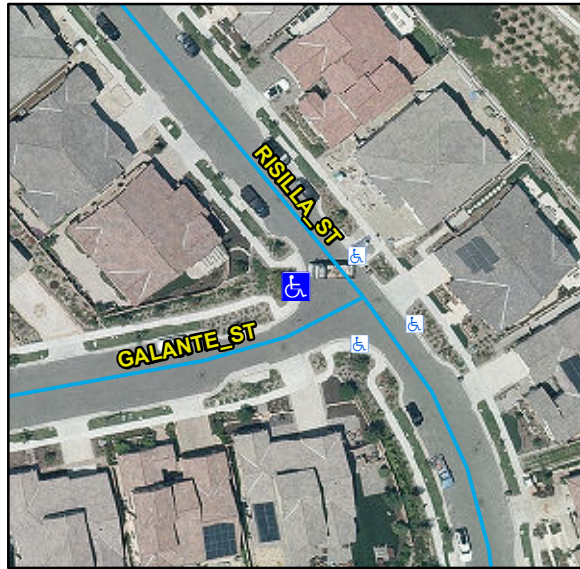
| Compliance | Description | Data | Compliance | Description | Data |
|---|---|---|---|---|---|
| No | Ramp Width LT (in) | 45 | No | Ramp Width RT (in) | 45 |

**Remove & Replace Curb Ramp With Two New Directional Ramps or Equivalent.**

**R304.5.1, STD 1115**
