# Access Compliance Report Public Rights-of-Way (Curb Ramps)

Main Street: RISILLA\_ST Cross Street: VOLAR\_ST Location: SW

ADA ID: RPRK211119132722 Ramp Type: Type 4 - Parallel Initial Pass/Fail: Fail Overall Compliance: No Severity Score: 19

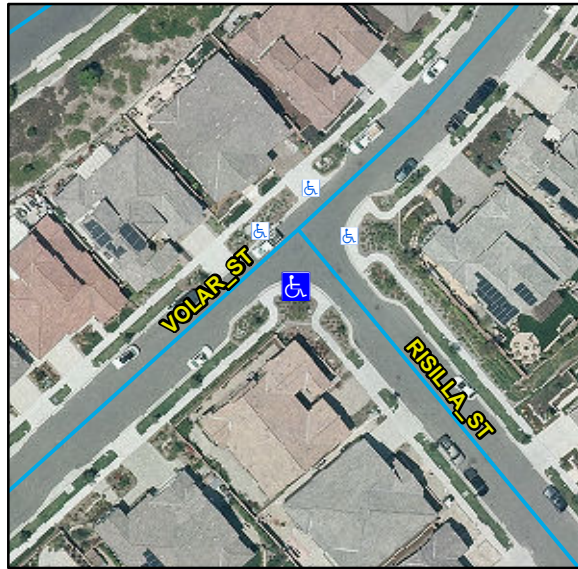
| Compliance | Description | Data | Compliance | Description | Data |
|---|---|---|---|---|---|
| No | Ramp Width LT (in) | 46 | No | Ramp Width RT (in) | 46 |
| Yes | Ramp Cross Slope LT (%) | 0.3 | No | Ramp Cross Slope RT (%) | 5.8 |

**Remove & Replace Curb Ramp With Two New Directional Ramps or Equivalent.**

**R304.5.1, R304.5.3, STD 1115**

Total Cost: \$ 4000
