# Access Compliance Report Public Rights-of-Way (Curb Ramps)

Main Street: CIMA\_DR Cross Street: VOLAR\_ST Location: S

ADA ID: RPRK211119134200 Ramp Type: Type 1 - Perpendicular Diagonal Initial Pass/Fail: Fail Overall Compliance: No Severity Score: 16

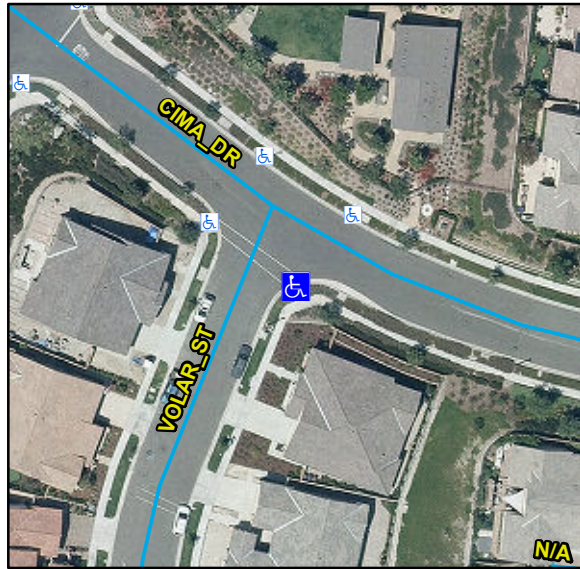
| Compliance | Description | Data | Compliance | Description | Data |
|---|---|---|---|---|---|
| No | Ramp Run Slope (%) | 8.5 | N/A | Flare Slope LT (%) | N/A |
| No | Ramp Cross Slope (%) | 2.5 | N/A | Flare Traversable LT | N/A |

Remove & Replace Curb Ramp With Two New Directional Ramps or Equivalent.

R304.2.2, R304.5.3, STD 1115
