# Access Compliance Report Public Rights-of-Way (Curb Ramps)

Main Street: VOLAR\_ST Cross Street: CIMA\_DR Location: W

ADA ID: RPRK211119134511 Ramp Type: Type 1 - Perpendicular Diagonal Initial Pass/Fail: Pass Overall Compliance: No Severity Score: 0

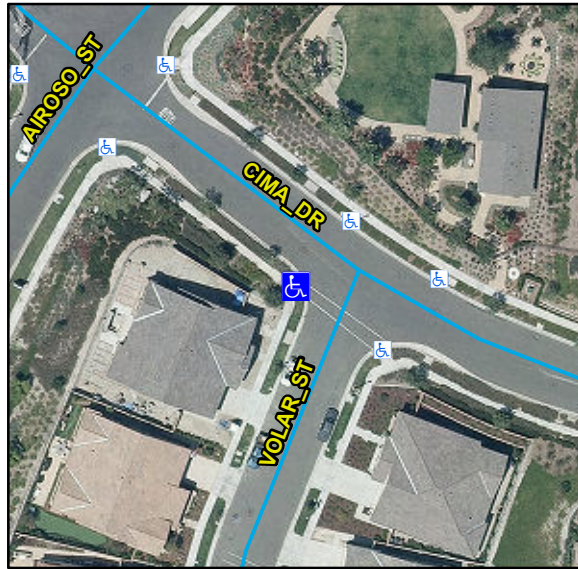
| Compliance | Description | Data | Compliance | Description | Data |
|---|---|---|---|---|---|
| No | Gutter Cross Slope (%) | 7 | | | |

Remove & Replace Gutter.

R304.5.3, STD 1115
