# Access Compliance Report Public Rights-of-Way (Curb Ramps)

| Main Street: ARRIATE_ST | | Cross Street: GRANJA_CT | | Location: | SE |
| ADA ID: RPRK211119135459 | Ramp Type: Type 4 - Parallel | Initial Pass/Fail: Fail | Overall Compliance: No | Severity Score: | 15 |

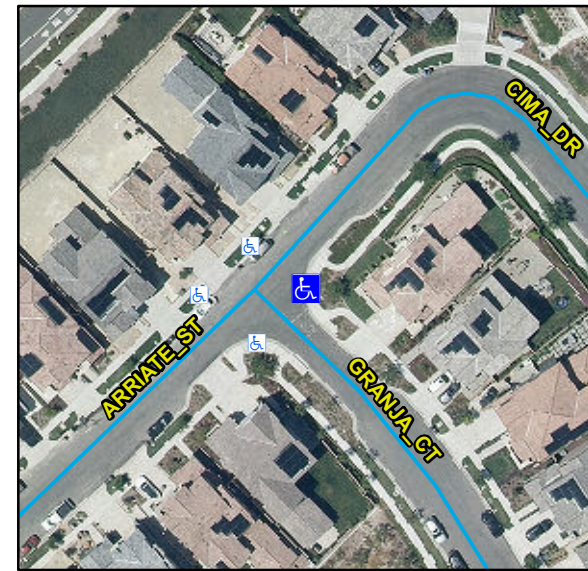
| Compliance | Description | Data | Compliance | Description | Data |
|---|---|---|---|---|---|
| No | Ramp Run Slope LT (%) | 9.4 | Yes | Ramp Run Slope RT (%) | 4.9 |

Possible Solutions:

**Remove & Replace Curb Ramp With Two New Directional Ramps or Equivalent.**

**R304.3.2, STD 1115**

Total Cost: \$ 4000

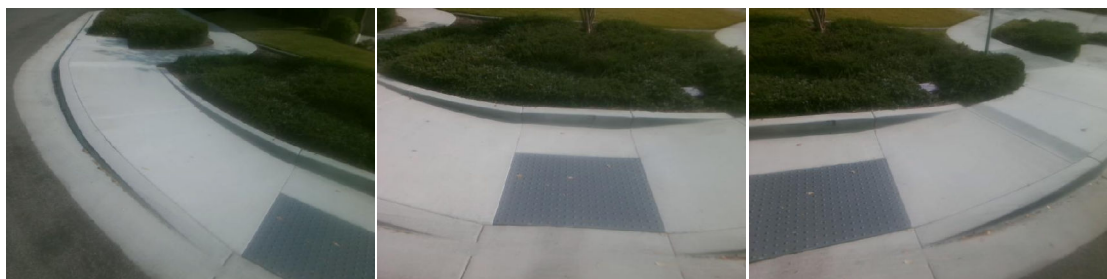
| Compliance | Description | Data | Compliance | Description | Data |
|---|---|---|---|---|---|
| N/A | Ramp Length LT (in) | 84 | N/A | Ramp Length RT (in) | 64 |
| Yes | Ramp Width LT (in) | 60 | Yes | Ramp Width RT (in) | 60 |
| Yes | Ramp Cross Slope LT (%) | 1.2 | Yes | Ramp Cross Slope RT (%) | 0.6 |
