# Access Compliance Report Public Rights-of-Way (Curb Ramps)

Main Street: GRANJA\_CT Cross Street: ARRIATE\_ST Location: S

ADA ID: RPRK211119135855 Ramp Type: Type 4 - Parallel Initial Pass/Fail: Fail Overall Compliance: No Severity Score: 15

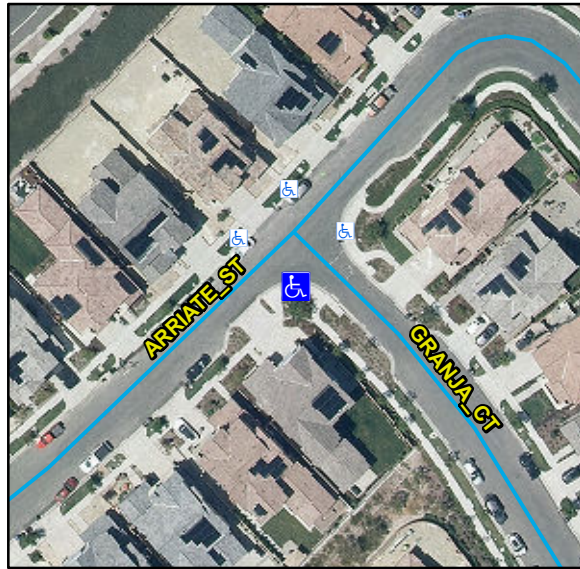
| Compliance | Description | Data | Compliance | Description | Data |
|---|---|---|---|---|---|
| No | Ramp Run Slope LT (%) | 9.1 | Yes | Ramp Run Slope RT (%) | 6.1 |

**Remove & Replace Curb Ramp With Two New Directional Ramps or Equivalent.**

**R304.3.2, STD 1115**

Total Cost: \$ 4000
