# Access Compliance Report Public Rights-of-Way (Curb Ramps)

Main Street: ARRIATE\_ST Cross Street: GRANJA\_CT Location: W

ADA ID: RPRK211119140326 Ramp Type: Type 1 - Perpendicular Initial Pass/Fail: Pass Overall Compliance: No Severity Score: 16

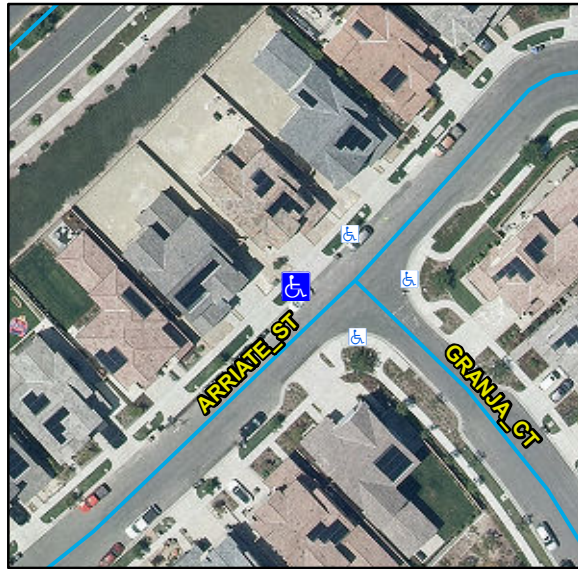
| Compliance | Description | Data | Compliance | Description | Data |
|---|---|---|---|---|---|
| No | Landing Cross Slope (%) | 2.4 | No | DWS Provided | No |
| Yes | Gutter Ponding | No | No | Curb Slope | 6.3 |
| No | Gutter Run Slope (%) | 7.5 | | Road Cross Slope (%) | N/A |

Remove & Replace Entire Ramp. Remove & Replace Gutter.

R304.2.2, R304.5.3, R305, R304.5.4, STD 1115
