# Access Compliance Report Public Rights-of-Way (Curb Ramps)

Main Street: VAGAR\_ST Cross Street: PLATAL\_ST Location: SW

ADA ID: RPRK211119141303 Ramp Type: Type 4 - Parallel Initial Pass/Fail: Fail Overall Compliance: No Severity Score: 2

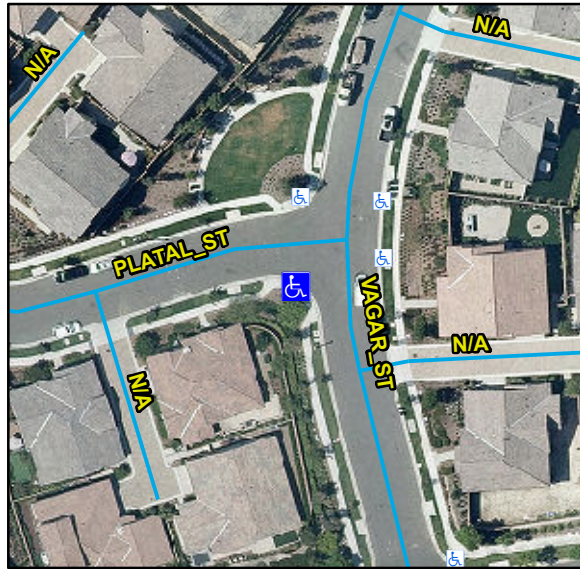
| Compliance | Description | Data | Compliance | Description | Data |
|---|---|---|---|---|---|
| No | Ramp Cross Slope LT (%) | 2.2 | Yes | Ramp Cross Slope RT (%) | 1.9 |
| N/A | Gutter Ponding | N/A | No | Curb Slope | 10.1 |

Remove & Replace Curb Ramp With Two New Directional Ramps or Equivalent.

R304.2.2, R304.5.3, STD 1115

Total Cost: \$ 4000
