# Access Compliance Report Public Rights-of-Way (Curb Ramps)

Main Street: PLATAL\_ST Cross Street: VAGAR\_ST Location: NW

ADA ID: RPRK211119141652 Ramp Type: Type 4 - Parallel Initial Pass/Fail: Fail Overall Compliance: No Severity Score: 5

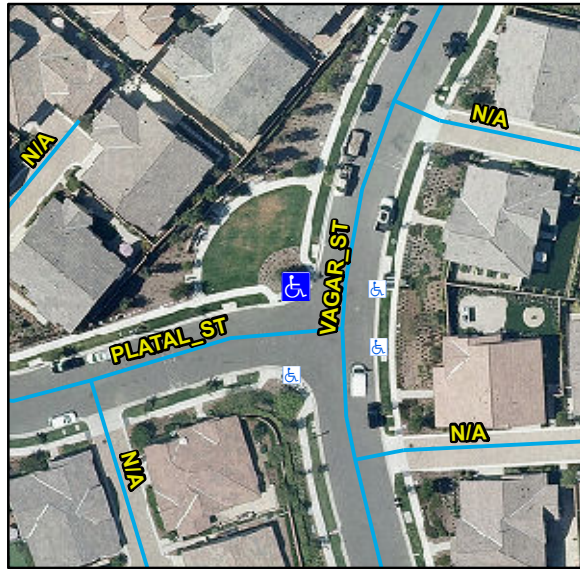
| Compliance | Description | Data | Compliance | Description | Data |
|---|---|---|---|---|---|
| No | Ramp Width LT (in) | 46 | No | Ramp Width RT (in) | 46 |
| No | Ramp Cross Slope LT (%) | 3.2 | Yes | Ramp Cross Slope RT (%) | 1.3 |

Remove & Replace Curb Ramp With Two New Directional Ramps or Equivalent.

R304.5.1, R304.5.3, STD 1115
