# Access Compliance Report Public Rights-of-Way (Curb Ramps)

Main Street: VAGAR\_ST Cross Street: AIROSO\_ST Location: NE

ADA ID: RPRK211119142319 Ramp Type: Type 1 - Perpendicular Diagonal Initial Pass/Fail: Pass Overall Compliance: No Severity Score: 0

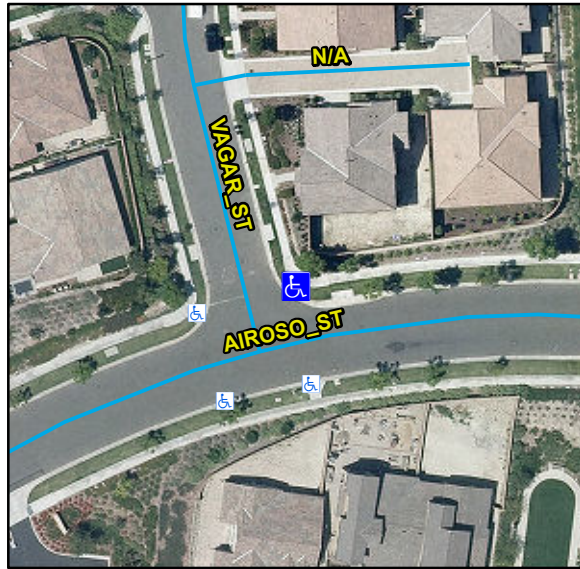
R304.5.3, STD 1115

| Compliance | Description | Data | Compliance | Description | Data |
|---|---|---|---|---|---|
| No | Gutter Cross Slope (%) | 4.8 | | | |

Remove & Replace Gutter.
