# Access Compliance Report Public Rights-of-Way (Curb Ramps)

Main Street: AIROSO\_ST Cross Street: AIROSO\_ST Location: SE

ADA ID: RPRK211119142739 Ramp Type: Type 1 - Perpendicular Initial Pass/Fail: Pass Overall Compliance: No Severity Score: 25

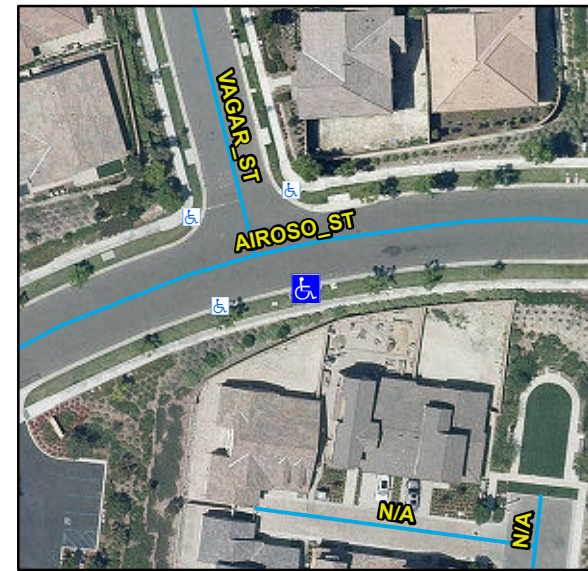
| Compliance | Description | Data | Compliance | Description | Data |
|---|---|---|---|---|---|
| No | Landing Cross Slope (%) | 7.9 | No | DWS Provided | No |
| Yes | Gutter Ponding | No | No | Curb Slope | 14 |
| No | Gutter Lip Height (in) | 2.7 | | Road Run Slope (%) | N/A |
| No | Gutter Cross Slope (%) | 8 | | | |

Remove & Replace Entire Ramp. Remove & Replace Gutter.

R304.2.2, R304.5.3, R305, R302.7.2, STD 1115
