# Access Compliance Report Public Rights-of-Way (Curb Ramps)

Main Street: AIROSO\_ST Cross Street: VAGAR\_ST Location: NW

ADA ID: RPRK211119143302 Ramp Type: Type 1 - Perpendicular Diagonal Initial Pass/Fail: Fail Overall Compliance: No Severity Score: 2

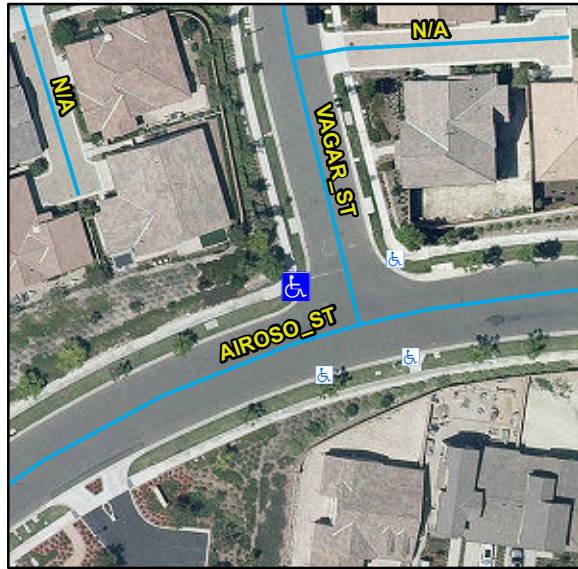
| Compliance | Description | Data | Compliance | Description | Data |
|---|---|---|---|---|---|
| No | Ramp Cross Slope (%) | 3.1 | N/A | Flare Traversable LT | N/A |

Remove & Replace Curb Ramp With Two New Directional Ramps or Equivalent.

R304.2.2, R304.5.3, STD 1115
