# Access Compliance Report Public Rights-of-Way (Curb Ramps)

Main Street: CIMA\_DR Cross Street: AIROSO\_ST Location: S

ADA ID: RPRK211119145443 Ramp Type: Type 1 - Perpendicular Diagonal Initial Pass/Fail: Fail Overall Compliance: No Severity Score: 2

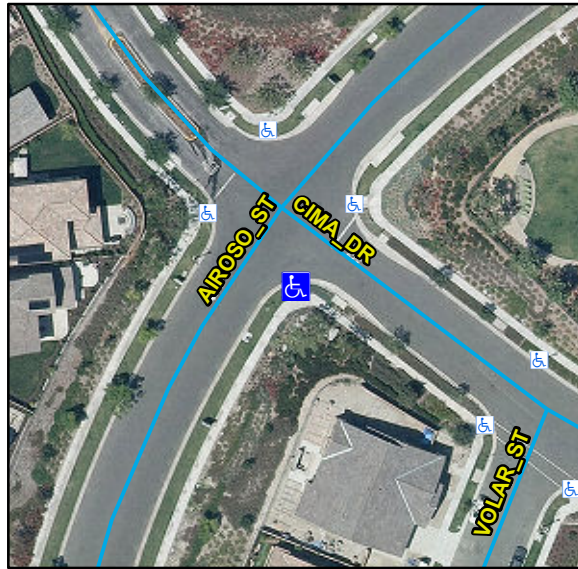
| Compliance | Description | Data | Compliance | Description | Data |
|---|---|---|---|---|---|
| No | Ramp Cross Slope (%) | 4.1 | N/A | Flare Traversable LT | N/A |

Remove & Replace Curb Ramp With Two New Directional Ramps or Equivalent.
