# Access Compliance Report Public Rights-of-Way (Curb Ramps)

Main Street: CIMA\_DR Cross Street: AIROSO\_ST Location: N

ADA ID: RPRK211119150037 Ramp Type: Type 1 - Perpendicular Diagonal Initial Pass/Fail: Pass Overall Compliance: No Severity Score: 0

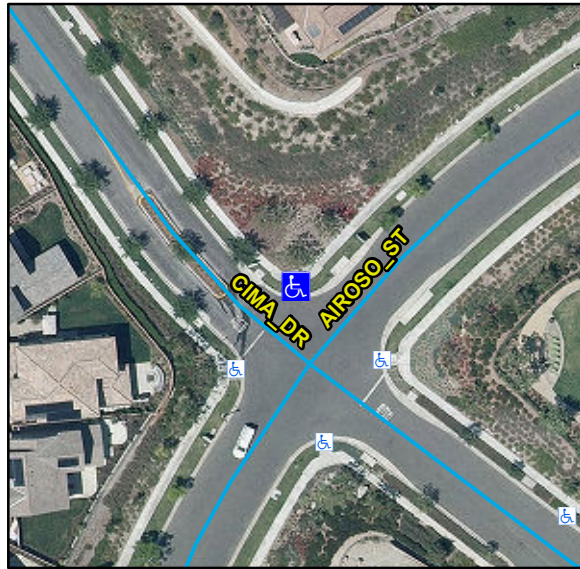
| Compliance | Description | Data | Compliance | Description | Data |
|---|---|---|---|---|---|
| No | Gutter Cross Slope (%) | 3.4 | | | |

Possible Solutions:

Remove & Replace Gutter.

OC Std/PROW:

R304.5.3, STD 1115
