# Access Compliance Report Public Rights-of-Way (Curb Ramps)

Main Street: AIROSO\_ST Cross Street: CIMA\_DR Location: SE

ADA ID: RPRK211119150459 Ramp Type: Type 1 - Perpendicular Diagonal Initial Pass/Fail: Fail Overall Compliance: No Severity Score: 16

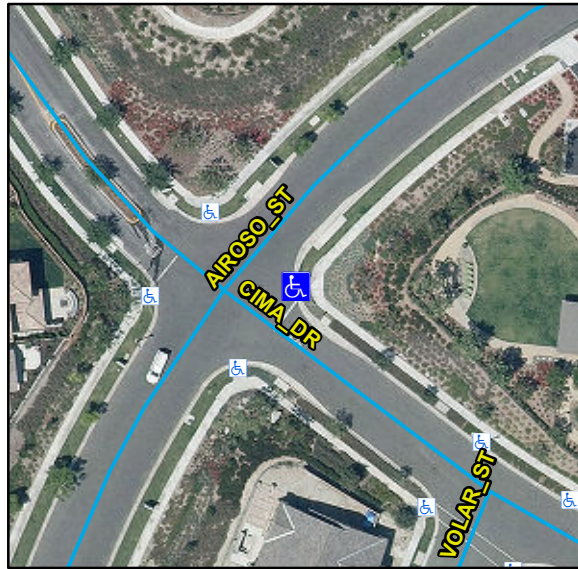
| Compliance | Description | Data | Compliance | Description | Data |
|---|---|---|---|---|---|
| No | Ramp Run Slope (%) | 8.4 | N/A | Flare Slope LT (%) | N/A |
| No | Ramp Cross Slope (%) | 2.9 | N/A | Flare Traversable LT | N/A |
| N/A | Gutter Ponding | N/A | No | Curb Slope | 11.8 |

**Remove & Replace Curb Ramp With Two New Directional Ramps or Equivalent.**

**R304.2.2, R304.5.3, STD 1115**
