# Access Compliance Report Public Rights-of-Way (Curb Ramps)

| Main Street: ANTONIO_PKWY | | Cross Street: N/A | | Location: | E |
| ADA ID: RPRK211122113218 | Ramp Type: Type 1 - Perpendicular Diagonal Initial Pass/Fail: Pass | | Overall Compliance: No | Severity Score: | 10 |

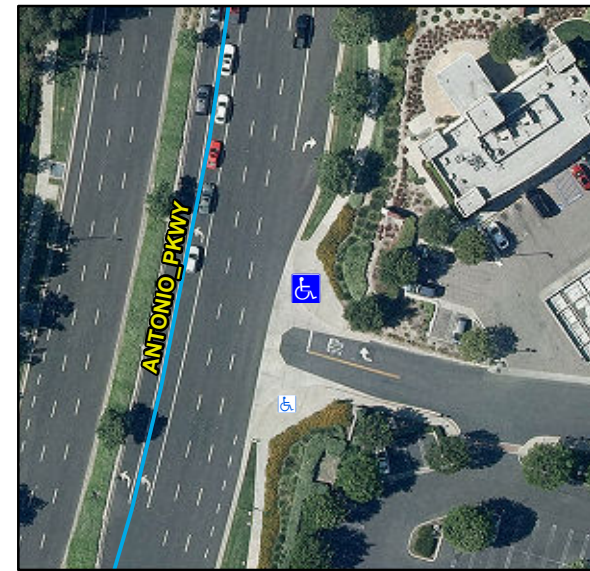
| Compliance | Description | Data | Compliance | Description | Data |
|---|---|---|---|---|---|
| No | Landing Run Slope (%) | 2.1 | N/A | Flare Traversable RT | Yes |
| Yes | Landing Cross Slope (%) | 0.5 | No | DWS Provided | No |
| Yes | Gutter Ponding | No | No | Curb Slope | 6.5 |

**Remove & Replace Curb Ramp With Two New Directional Ramps or Equivalent.**

**R304.2.2, R304.2.1, R304.2.2-Perp, R304.3.2-Para, R305, STD 1115**

Total Cost: \$ 6160
