# Access Compliance Report Public Rights-of-Way (Curb Ramps)

Main Street: N/A Cross Street: ANTONIO\_PKWY Location: E

ADA ID: RPRK211122113705 Ramp Type: Type 1 - Perpendicular Diagonal Initial Pass/Fail: Fail Overall Compliance: No Severity Score: 2

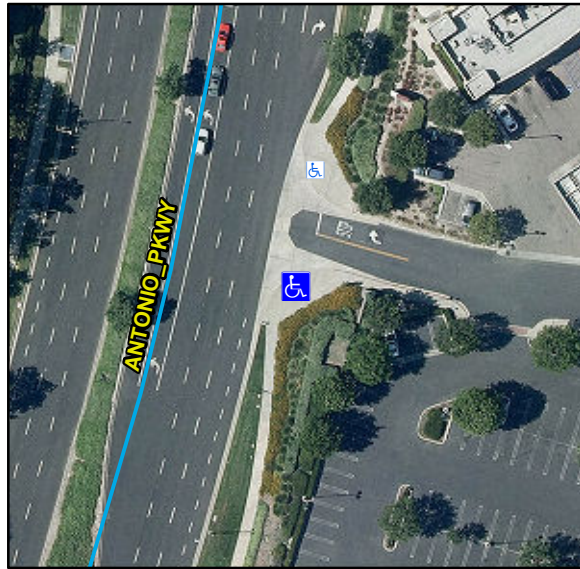
| Compliance | Description | Data | Compliance | Description | Data |
|---|---|---|---|---|---|
| No | Ramp Cross Slope (%) | 3.3 | N/A | Flare Traversable LT | N/A |

Remove & Replace Curb Ramp With Two New Directional Ramps or Equivalent.

R204.3, R304.5.3, STD 1115
