# Access Compliance Report Public Rights-of-Way (Curb Ramps)

Main Street: ANTONIO\_PKWY Cross Street: N/A Location: E

ADA ID: RPRK211122114131 Ramp Type: Type 1 - Perpendicular Diagonal Initial Pass/Fail: Pass Overall Compliance: No Severity Score: 17

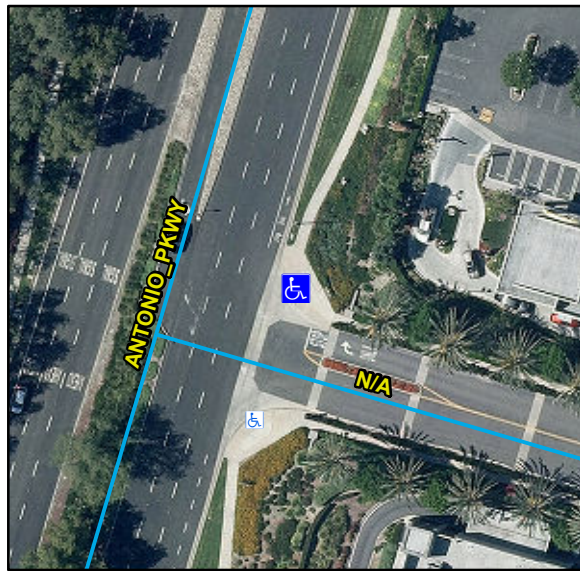
| Compliance | Description | Data | Compliance | Description | Data |
|---|---|---|---|---|---|
| Yes | Landing Width (in) | 54 | No | Flare Slope RT (%) | 10.8 |
| No | Landing Run Slope (%) | 4.8 | N/A | Flare Traversable RT | Yes |
| Yes | Landing Cross Slope (%) | 1.2 | No | DWS Provided | No |
| Yes | Gutter Ponding | No | No | Curb Slope | 5.4 |

Remove & Replace Curb Ramp With Two New Directional Ramps or Equivalent.

Total Cost: \$ 6160
