# Access Compliance Report Public Rights-of-Way (Curb Ramps)

Main Street: N/A Cross Street: ANTONIO\_PKWY Location: S

ADA ID: RPRK211122120014 Ramp Type: Type 1 - Perpendicular Diagonal Initial Pass/Fail: Fail Overall Compliance: No Severity Score: 15

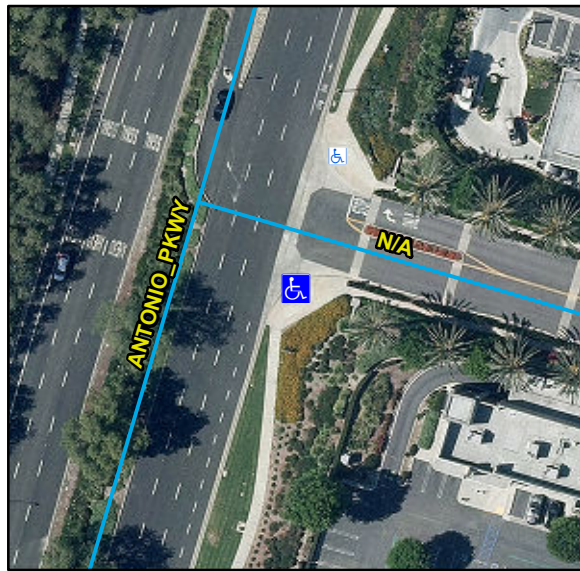
| Compliance | Description | Data | Compliance | Description | Data |
|---|---|---|---|---|---|
| No | Ramp Cross Slope (%) | 5.7 | N/A | Flare Traversable LT | N/A |

Remove & Replace Curb Ramp With Two New Directional Ramps or Equivalent.

R304.2.2, R204.3, R304.5.3, STD 1115
