# Access Compliance Report Public Rights-of-Way (Curb Ramps)

Main Street: IRISH\_MOSS\_ST Cross Street: N/A Location: NW

ADA ID: RPRK211122123240 Ramp Type: Type 4 - Parallel Initial Pass/Fail: Fail Overall Compliance: No Severity Score: 2

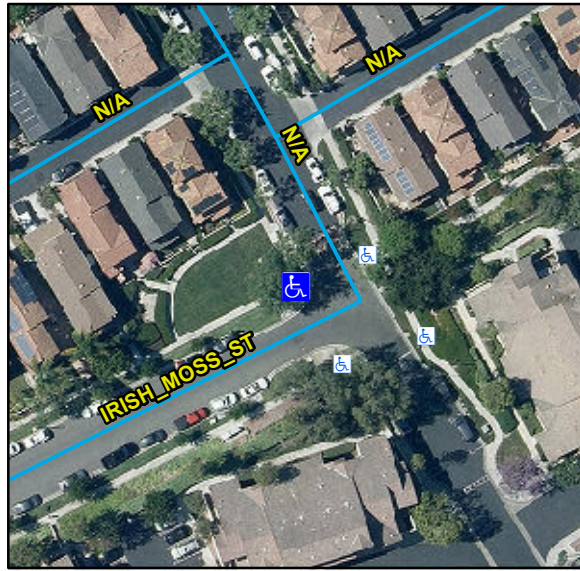
| Compliance | Description | Data | Compliance | Description | Data |
|---|---|---|---|---|---|
| Yes | Ramp Cross Slope LT (%) | 1.4 | No | Ramp Cross Slope RT (%) | 2.3 |

Remove & Replace Curb Ramp With Two New Directional Ramps or Equivalent.

R204.3, R304.5.3, STD 1115

Total Cost: \$ 4000
