# Access Compliance Report Public Rights-of-Way (Curb Ramps)

Main Street: N/A Cross Street: IRISH\_MOSS\_ST Location: SW

ADA ID: RPRK211122123708 Ramp Type: Type 4 - Parallel Initial Pass/Fail: Fail Overall Compliance: No Severity Score: 2

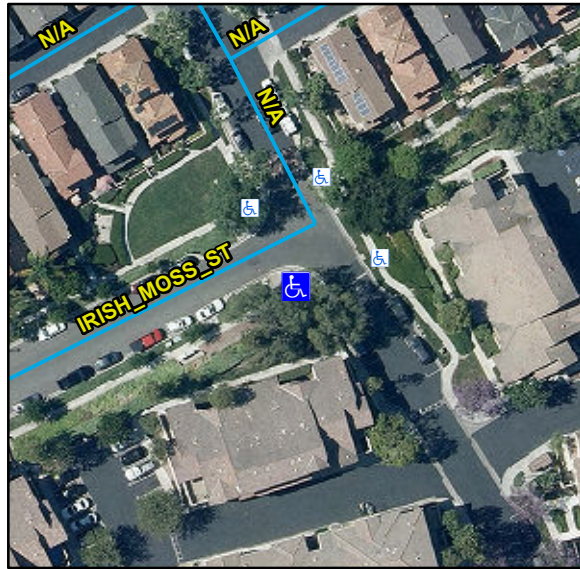
| Compliance | Description | Data | Compliance | Description | Data |
|---|---|---|---|---|---|
| No | Ramp Cross Slope LT (%) | 2.3 | No | Ramp Cross Slope RT (%) | 3.4 |

**Remove & Replace Curb Ramp With Two New Directional Ramps or Equivalent.**

**R204.3, R304.5.3, STD 1115**
