# Access Compliance Report Public Rights-of-Way (Curb Ramps)

Main Street: N/A Cross Street: SENDERO\_WAY Location: W

ADA ID: RPRK2111222125007 Ramp Type: Type 6 - Directional 1 Initial Pass/Fail: Pass Overall Compliance: No Severity Score: 5

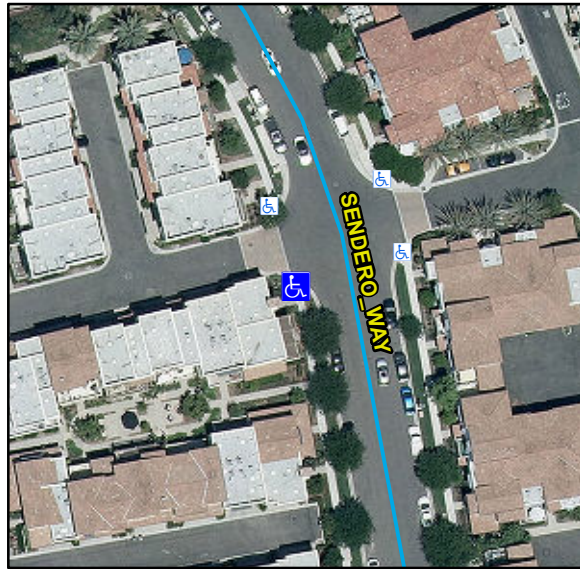
| Compliance | Description | Data | Compliance | Description | Data |
|---|---|---|---|---|---|
| No | Landing Cross Slope (%) | 2.6 | Yes | DWS Left Offset (in) | 0 |
| No | Gutter Run Slope (%) | 7.1 | | Road Cross Slope (%) | N/A |

**Remove & Replace Landing. Remove & Replace Gutter.**

**R304.5.3, R304.5.4, STD 1115**
