# Access Compliance Report Public Rights-of-Way (Curb Ramps)

Main Street: N/A Cross Street: SENDERO\_WAY Location: W

ADA ID: RPRK211122125352 Ramp Type: Type 7 - Directional 2 Initial Pass/Fail: Fail Overall Compliance: No Severity Score: 15

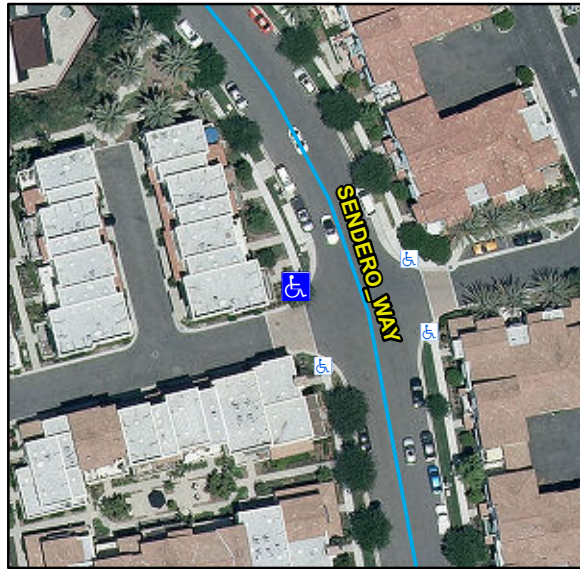
| Compliance | Description | Data | Compliance | Description | Data |
|---|---|---|---|---|---|
| No | Ramp Run Slope (%) | 8.9 | N/A | Flare Slope LT (%) | N/A |

Possible Solutions:

Remove & Replace Entire Ramp.

R304.2.2, STD 1115
