# Access Compliance Report Public Rights-of-Way (Curb Ramps)

Main Street: N/A Cross Street: AMADO\_PL Location: S

ADA ID: RPRK211122131534 Ramp Type: Type 6 - Directional 1 Initial Pass/Fail: Pass Overall Compliance: No Severity Score: 7

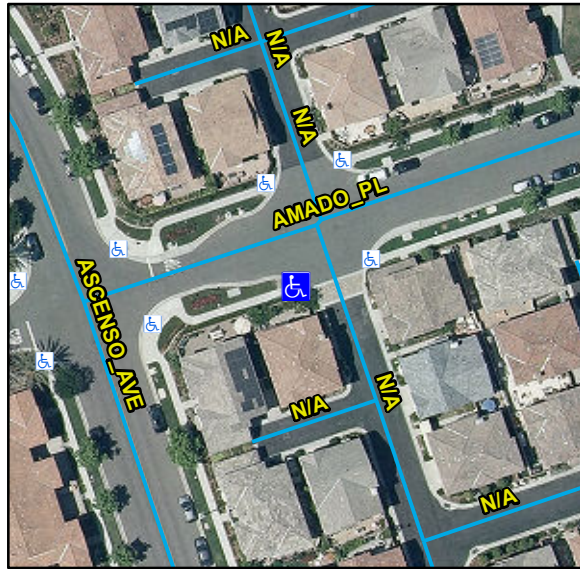
| Compliance | Description | Data | Compliance | Description | Data |
|---|---|---|---|---|---|
| No | Grade Break Slope (%) | 8.7 | | | Sloped |
| No | Landing Cross Slope (%) | 2.2 | Yes | DWS Left Offset (in) | 0 |
| No | Gutter Run Slope (%) | 8.6 | | Road Cross Slope (%) | N/A |
| No | Gutter Cross Slope (%) | 2.8 | | Parallel Ramp Side | Left |

Remove & Replace Entire Ramp. Remove & Replace Gutter.

R304.5.3, R304.5.4, STD 1115
