# Access Compliance Report Public Rights-of-Way (Curb Ramps)

Main Street: N/A Cross Street: AMADO\_PL Location: N

ADA ID: RPRK211122132025 Ramp Type: Type 6 - Directional 1 Initial Pass/Fail: Pass Overall Compliance: No Severity Score: 7

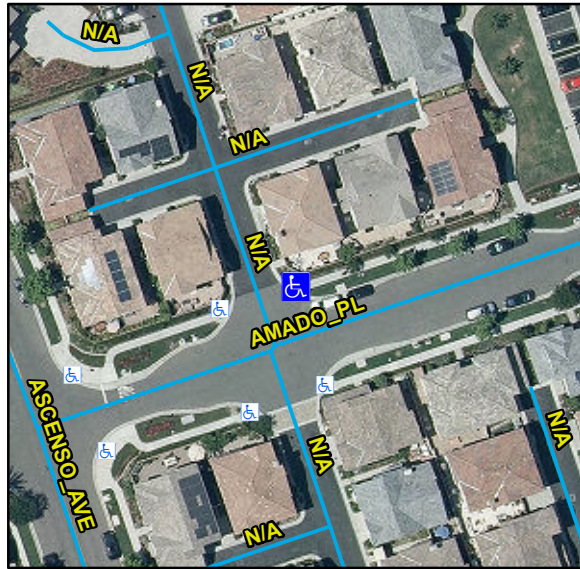
| Compliance | Description | Data | Compliance | Description | Data |
|---|---|---|---|---|---|
| No | Grade Break Slope (%) | 8.5 | | | Sloped |
| No | Landing Cross Slope (%) | 2.6 | No | DWS Left Offset (in) | 6 |
| Yes | Gutter Ponding | No | Yes | Curb Slope | 7 |
| No | Gutter Run Slope (%) | 6.3 | | Road Cross Slope (%) | N/A |

Remove & Replace Entire Ramp. Remove & Replace Gutter.

R304.5.3, R305.2, R304.5.4, STD 1115

Total Cost: \$ 3332
