# Access Compliance Report Public Rights-of-Way (Curb Ramps)

Main Street: N/A Cross Street: AMADO\_PL Location: S

ADA ID: RPRK211122132241 Ramp Type: Type 7 - Directional 2 Initial Pass/Fail: Fail Overall Compliance: No Severity Score: 15

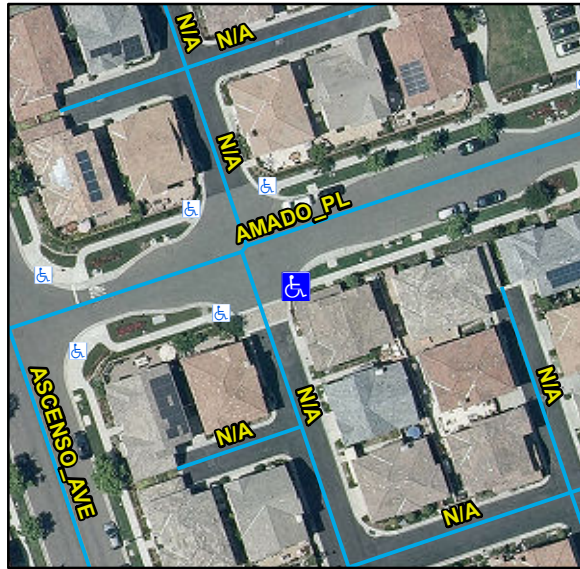
| Compliance | Description | Data | Compliance | Description | Data |
|---|---|---|---|---|---|
| No | Ramp Run Slope (%) | 11 | N/A | Flare Slope LT (%) | N/A |

Remove & Replace Entire Ramp.

R304.2.2, STD 1115
