# Access Compliance Report Public Rights-of-Way (Curb Ramps)

Main Street: N/A Cross Street: AMADO\_PL Location: N

ADA ID: RPRK211122132517 Ramp Type: Type 6 - Directional 1 Initial Pass/Fail: Pass Overall Compliance: No Severity Score: 7

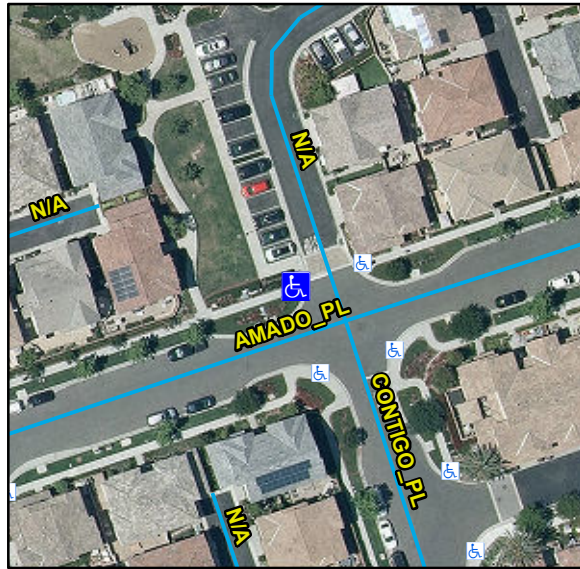
| Compliance | Description | Data | Compliance | Description | Data |
|---|---|---|---|---|---|
| No | Grade Break | No | Yes | Flare Type RT | |
| No | Landing Cross Slope (%) | 2.8 | Yes | DWS Left Offset (in) | 0 |
| No | Gutter Run Slope (%) | 6.2 | | Road Cross Slope (%) | N/A |

Remove & Replace Entire Ramp. Remove & Replace Gutter.
