# Access Compliance Report Public Rights-of-Way (Curb Ramps)

Main Street: N/A Cross Street: AMADO\_PL Location: N

ADA ID: RPRK211122133119 Ramp Type: Type 7 - Directional 2 Initial Pass/Fail: Fail Overall Compliance: No Severity Score: 15

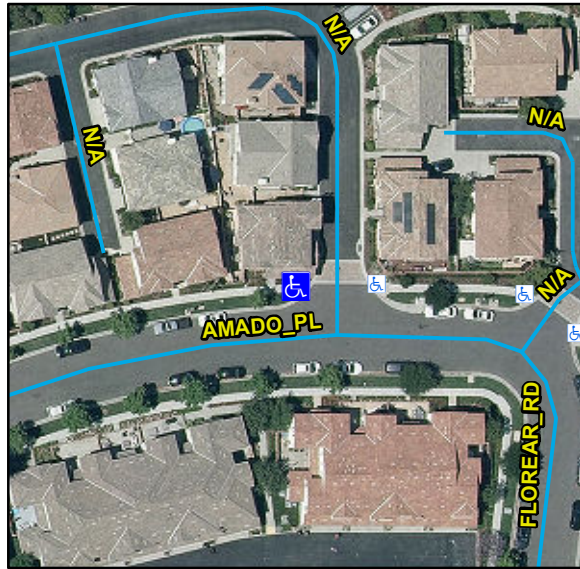
| Compliance | Description | Data | Compliance | Description | Data |
|---|---|---|---|---|---|
| No | Ramp Run Slope (%) | 9.9 | N/A | Flare Slope LT (%) | N/A |

Remove & Replace Entire Ramp.

R304.2.2, STD 1115
