# Access Compliance Report Public Rights-of-Way (Curb Ramps)

Main Street: N/A Cross Street: FLOREAR\_RD Location: E

ADA ID: RPRK211122134239 Ramp Type: Type 7 - Directional 2 Initial Pass/Fail: Fail Overall Compliance: No Severity Score: 16

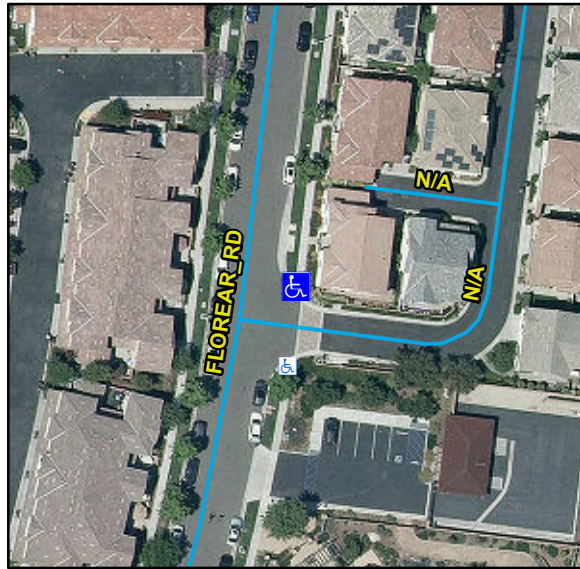
| Compliance | Description | Data | Compliance | Description | Data |
|---|---|---|---|---|---|
| No | Ramp Run Slope (%) | 9.5 | N/A | Flare Slope LT (%) | N/A |
| No | Ramp Cross Slope (%) | 2.5 | N/A | Flare Traversable LT | N/A |

Remove & Replace Entire Ramp.

R304.2.2, R304.5.3, STD 1115
