# Access Compliance Report Public Rights-of-Way (Curb Ramps)

Main Street: N/A Cross Street: FLOREAR\_RD Location: S

ADA ID: RPRK211122134357 Ramp Type: Type 6 - Directional 1 Initial Pass/Fail: Pass Overall Compliance: No Severity Score: 11

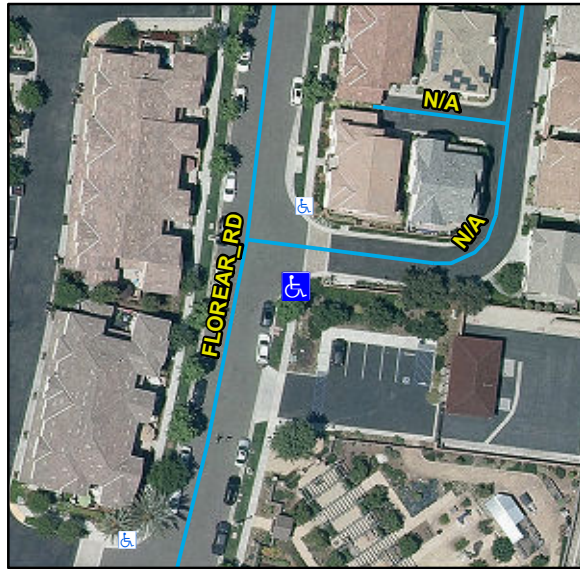
| Compliance | Description | Data | Compliance | Description | Data |
|---|---|---|---|---|---|
| No | Grade Break Cross Slope (%) | 2.1 | N/A | Flare Slope RT (%) | 8.3 |
| No | Landing Length (in) | 47 | Yes | DWS Length (in) | 72 |
| No | Landing Run Slope (%) | 3.8 | | DWS Offset Type | Single |
| No | Gutter Run Slope (%) | 7.8 | | Road Cross Slope (%) | N/A |

Remove & Replace Entire Ramp. Remove & Replace Gutter.
