# Access Compliance Report Public Rights-of-Way (Curb Ramps)

Main Street: N/A Cross Street: CONTIGO\_PL Location: W

ADA ID: RPRK211122134914 Ramp Type: Type 7 - Directional 2 Initial Pass/Fail: Fail Overall Compliance: No Severity Score: 15

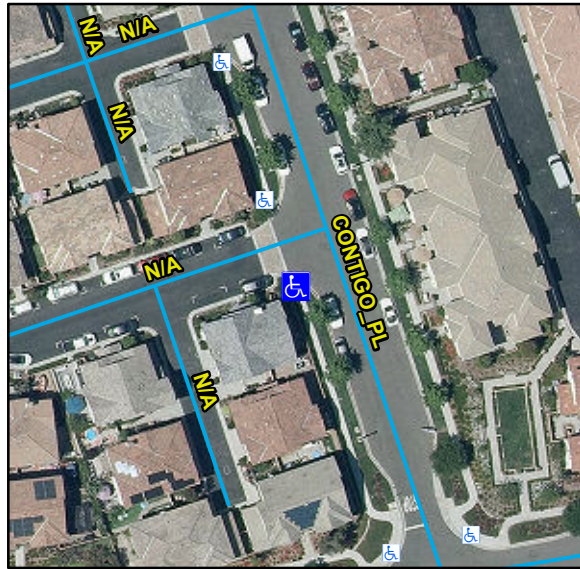
| Compliance | Description | Data | Compliance | Description | Data |
|---|---|---|---|---|---|
| No | Ramp Run Slope (%) | 9.7 | N/A | Flare Slope LT (%) | N/A |

Possible Solutions:

Remove & Replace Entire Ramp.

R304.2.2, STD 1115
