# Access Compliance Report Public Rights-of-Way (Curb Ramps)

Main Street: N/A Cross Street: CONTIGO\_PL Location: W

ADA ID: RPRK211122135314 Ramp Type: Type 7 - Directional 2 Initial Pass/Fail: Fail Overall Compliance: No Severity Score: 15

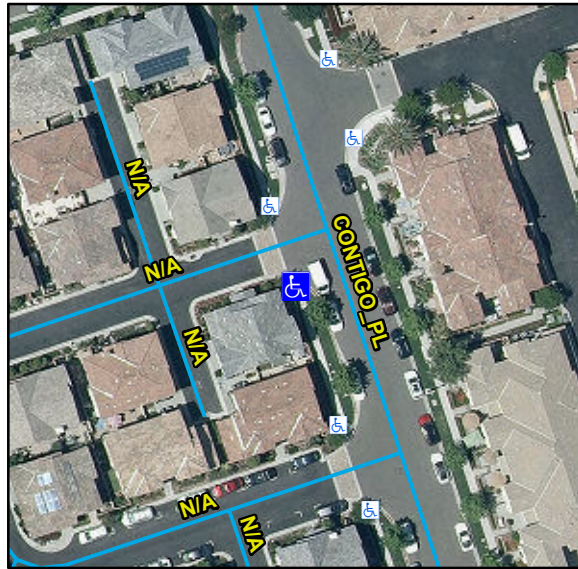
| Compliance | Description | Data | Compliance | Description | Data |
|---|---|---|---|---|---|
| No | Ramp Run Slope (%) | 9.2 | N/A | Flare Slope LT (%) | N/A |

Possible Solutions:

Remove & Replace Entire Ramp.

R304.2.2, STD 1115
