# Access Compliance Report Public Rights-of-Way (Curb Ramps)

Main Street: N/A Cross Street: CONTIGO\_PL Location: E

ADA ID: RPRK211122135621 Ramp Type: Type 6 - Directional 1 Initial Pass/Fail: Pass Overall Compliance: No Severity Score: 0

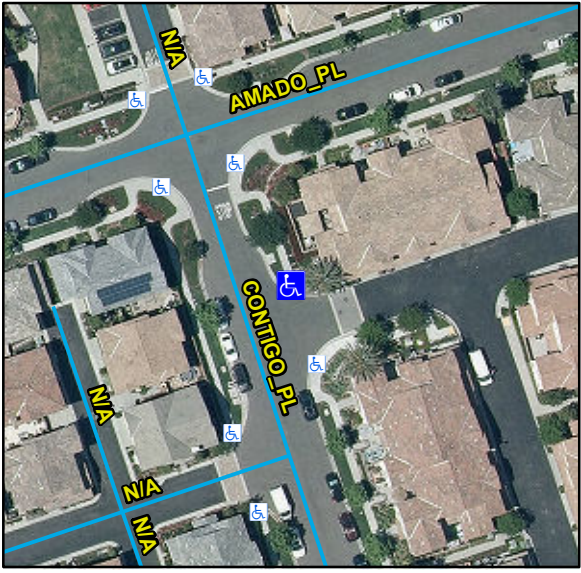
Compliance	Description	Data	Compliance	Description	Data
N/A	Ramp Length (in)	108	N/A	Flare Type LT	
Yes	Ramp Width (in)	48			Sloped
Yes	Ramp Run Slope (%)	8.3	N/A	Flare Slope LT (%)	9.7
Yes	Ramp Cross Slope (%)	1.1	N/A	Flare Traversable LT	No
Yes	Grade Break	Yes	Yes	Flare Type RT	
Yes	Grade Break Slope (%)	2.2			Curbed2
No	Grade Break Cross Slope (%)	3	N/A	Flare Slope RT (%)	N/A
	Addl Para Ramp Left?	No	N/A	Flare Traversable RT	N/A
	Addl Para Ramp Right?	No	Yes	DWS Provided	Yes
N/A	Landing Present	Yes	Yes	DWS Contrast	Yes
Yes	Landing Length (in)	49	Yes	DWS Length (in)	72
Yes	Landing Width (in)	48	Yes	DWS Full Width	Yes
Yes	Landing Run Slope (%)	0.2		DWS Offset Type	Single
No	Landing Cross Slope (%)	3.8	Yes	DWS Left Offset (in)	0
N/A	Landing Movement Obstructed?	No	N/A	DWS Right Offset (in)	0
	Landing Movement Type	N/A			
N/A	Landing Shared	No			
N/A	Marked Crosswalk 1	No	N/A	Clear Space	N/A
	Crossing 1 Direction	S	N/A	Clear Space To Crosswalk (in)	N/A

Marked Crosswalk 1 Width (in)	N/A			
N/A	Ramp Inside Crosswalk 1	N/A			
	Crossing 1 Slope (%)	1.4			
	Crossing 1 Cross Slope (%)	2.9			
Yes	Gutter Ponding	No	Yes	Curb Slope	1.9
Yes	Gutter Lip Height (in)	0		Road Run Slope (%)	N/A
Yes	Gutter Run Slope (%)	4.5		Road Cross Slope (%)	N/A
Yes	Gutter Cross Slope (%)	1.3		Parallel Ramp Side	Right
Yes	Overall Surface Condition	Acceptable	Yes	Perp Joint Present	Yes
	Cross Gutter Present?	No		Spandrel Present?	No
	Replace Cross Gutter?	N/A		Replace Spandrel?	N/A

Possible Solutions:  
**Remove & Replace Entire Ramp.**

OC Std/PROW:  
**R304.5.3, STD 1115**

Total Cost: \$ 3080
