# Access Compliance Report Public Rights-of-Way (Curb Ramps)

| Main Street: N/A | | Cross Street: ORTEGA_HWY | | Location: | S |
| ADA ID: RPRK211122140521 | Ramp Type: Type 1 - Perpendicular | Initial Pass/Fail: Fail | Overall Compliance: No | Severity Score: | 16 |

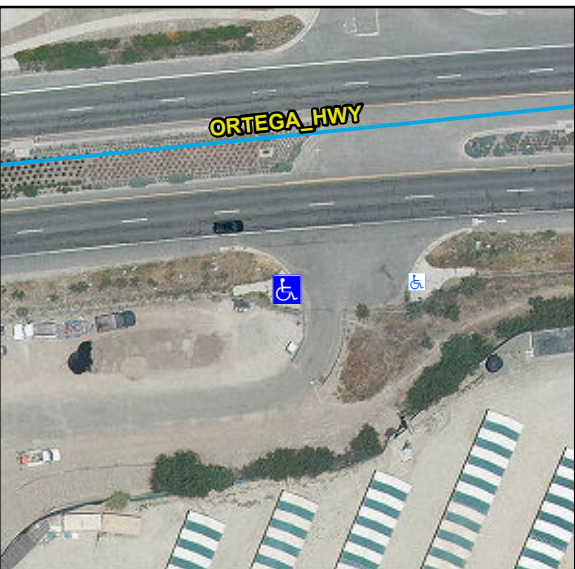
R304.2.2, R304.5.3, STD 1115

| Compliance | Description | Data | Compliance | Description | Data |
|---|---|---|---|---|---|
| No | Ramp Run Slope (%) | 8.7 | N/A | Flare Slope LT (%) | N/A |
| No | Ramp Cross Slope (%) | 4 | N/A | Flare Traversable LT | N/A |

Remove & Replace Entire Ramp.
