# Access Compliance Report Public Rights-of-Way (Curb Ramps)

Main Street: ORTEGA\_HWY Cross Street: N/A Location: N

ADA ID: RPRK211122140809 Ramp Type: Type 1 - Perpendicular Diagonal Initial Pass/Fail: Pass Overall Compliance: No Severity Score: 0

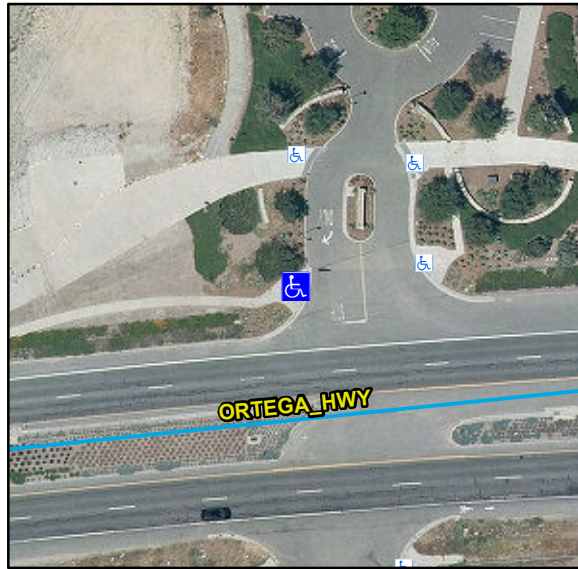
| Compliance | Description | Data | Compliance | Description | Data |
|---|---|---|---|---|---|
| No | Landing Run Slope (%) | 2.8 | N/A | Flare Traversable RT | Yes |
| No | Gutter Ponding | Yes | No | Curb Slope | 11.8 |

Remove & Replace Curb Ramp With Two New Directional Ramps or Equivalent.
