# Access Compliance Report Public Rights-of-Way (Curb Ramps)

Main Street: N/A Cross Street: ORTEGA\_HWY Location: N

ADA ID: RPRK211122141235 Ramp Type: Type 1 - Perpendicular Diagonal Initial Pass/Fail: Pass Overall Compliance: No Severity Score: 0

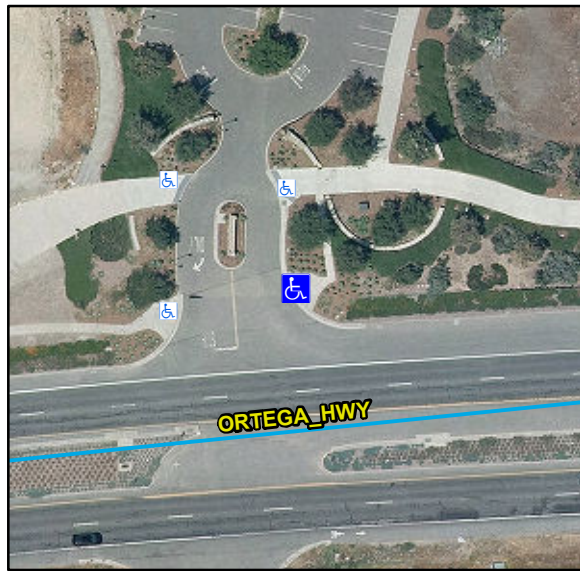
| Compliance | Description | Data | Compliance | Description | Data |
|---|---|---|---|---|---|
| Yes | Gutter Ponding | No | No | Curb Slope | 11.6 |
| No | Gutter Cross Slope (%) | 4.1 | | | |

Remove & Replace Curb Slope. Remove & Replace Gutter.
