# Access Compliance Report Public Rights-of-Way (Curb Ramps)

| Main Street: ANTONIO_PKWY | | Cross Street: ORTEGA_HWY | | Location: | NE |
| ADA ID: RPRK211122142818 | Ramp Type: Type 1 - Perpendicular | Initial Pass/Fail: Fail | Overall Compliance: No | Severity Score: | 15 |

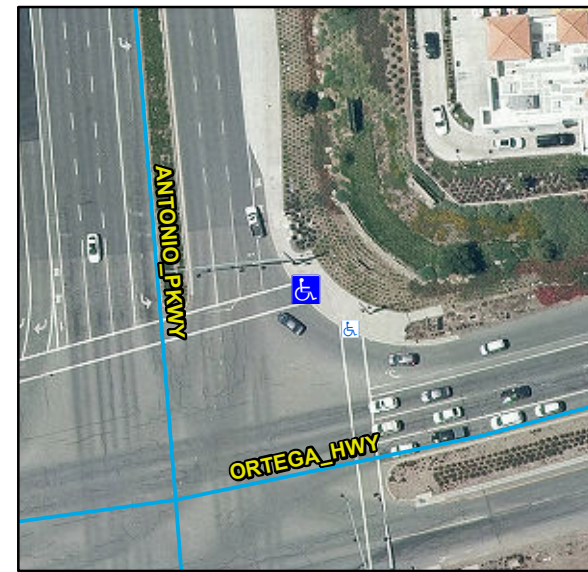
R304.5.3, STD 1115

| Compliance | Description | Data | Compliance | Description | Data |
|---|---|---|---|---|---|
| No | Ramp Cross Slope (%) | 6.5 | N/A | Flare Traversable LT | N/A |

Possible Solutions:

Remove & Replace Entire Ramp.
