# Access Compliance Report Public Rights-of-Way (Curb Ramps)

| Main Street: ORTEGA_HWY | | Cross Street: ANTONIO_PKWY | | Location: | NE |
| ADA ID: RPRK211122143527 | Ramp Type: Type 1 - Perpendicular | Initial Pass/Fail: Fail | Overall Compliance: No | Severity Score: | 2 |

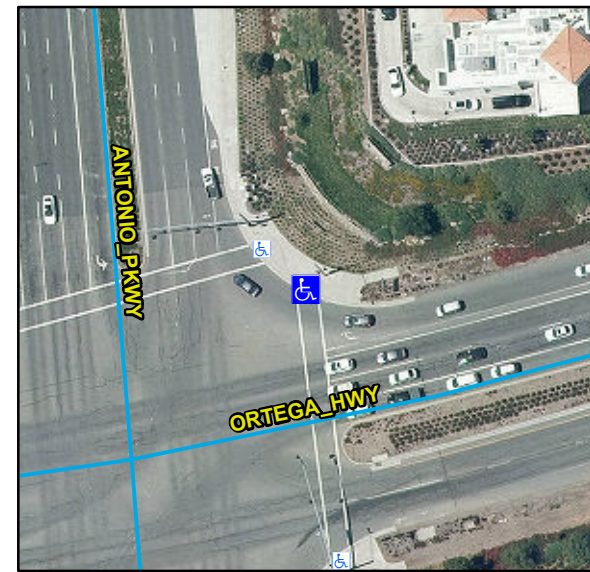
R304.5.3, STD 1115

| Compliance | Description | Data | Compliance | Description | Data |
|---|---|---|---|---|---|
| No | Ramp Cross Slope (%) | 4.2 | N/A | Flare Traversable LT | N/A |

Remove & Replace Entire Ramp.

Total Cost: \$ 3080
