# Access Compliance Report Public Rights-of-Way (Curb Ramps)

| Main Street: ORTEGA_HWY | | Cross Street: AVENIDA_LA_PATA | | Location: | SE |
| ADA ID: RPRK211122143737 | Ramp Type:Type 1 - Perpendicular | Initial Pass/Fail: Pass | Overall Compliance: No | Severity Score: | 9 |

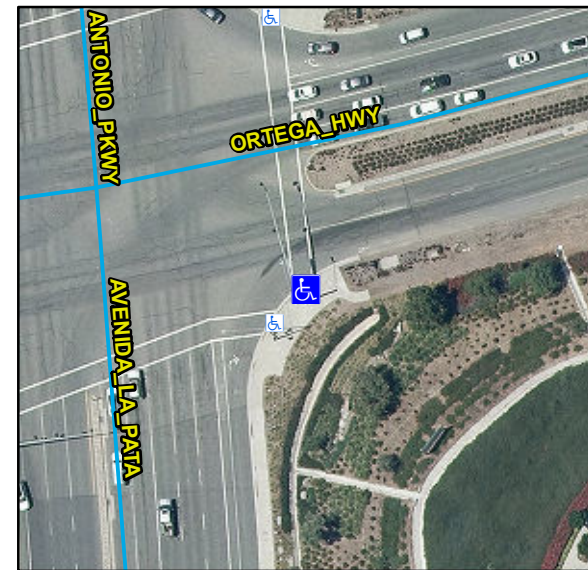
| Compliance | Description | Data | Compliance | Description | Data |
|---|---|---|---|---|---|
| No | Landing Run Slope (%) | 3.5 | N/A | Flare Traversable RT | No |
| No | Landing Cross Slope (%) | 5.3 | Yes | DWS Provided | Yes |
| No | Gutter Cross Slope (%) | 5.3 | | | |

Remove & Replace Entire Ramp. Remove & Replace Gutter. Utility Present.

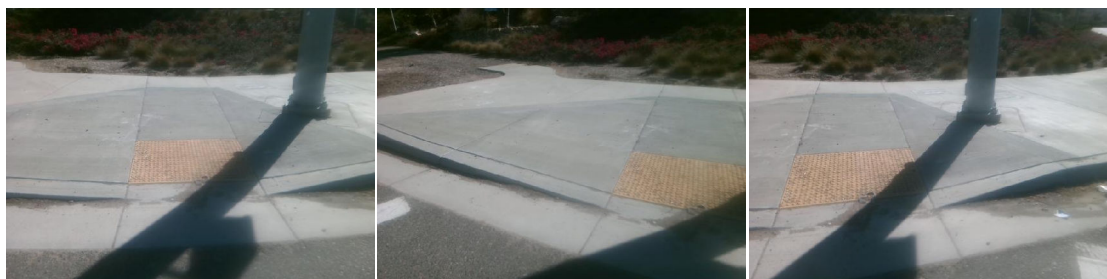
| Compliance | Description | Data | Compliance | Description | Data |
|---|---|---|---|---|---|
| Yes | Obstructions Present? | No | N/A | Utilities Present? | Yes |
| | Obstruction Types | N/A | | Utility Types | |
| | Obstruction Dimensions | N/A | | Traffic Signal Pole | |
