# Access Compliance Report Public Rights-of-Way (Curb Ramps)

| Main Street: AVENIDA_LA_PATA | | Cross Street: ORTEGA_HWY | | Location: | SE |
| ADA ID: RPRK211122144311 | Ramp Type: Type 1 - Perpendicular | Initial Pass/Fail: Fail | Overall Compliance: No | Severity Score: | 15 |

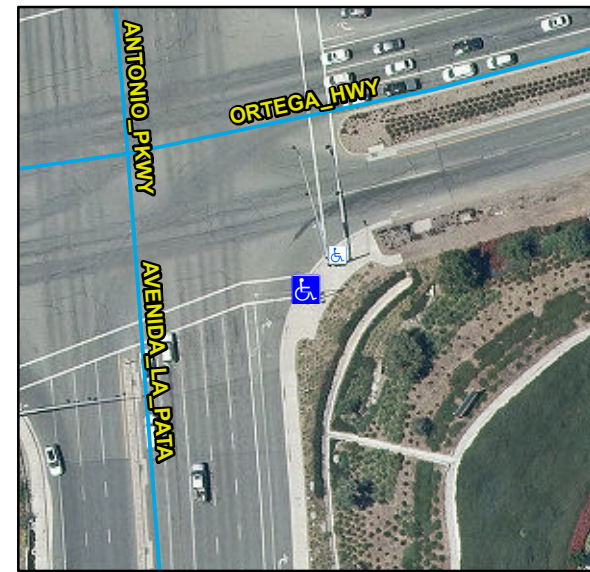
| Compliance | Description | Data | Compliance | Description | Data |
|---|---|---|---|---|---|
| No | Ramp Run Slope (%) | 9.4 | N/A | Flare Slope LT (%) | N/A |
| N/A | Gutter Ponding | N/A | No | Curb Slope | 10.8 |

Remove & Replace Entire Ramp.

R304.2.2, STD 1115

Total Cost: \$ 3080
