# Access Compliance Report Public Rights-of-Way (Curb Ramps)

Main Street: AGAPANTHUS\_ST Cross Street: PINK\_TRUMPET\_ST Location: SE

ADA ID: RPRK211122164931 Ramp Type: Type 4 - Parallel Initial Pass/Fail: Fail Overall Compliance: No Severity Score: 2

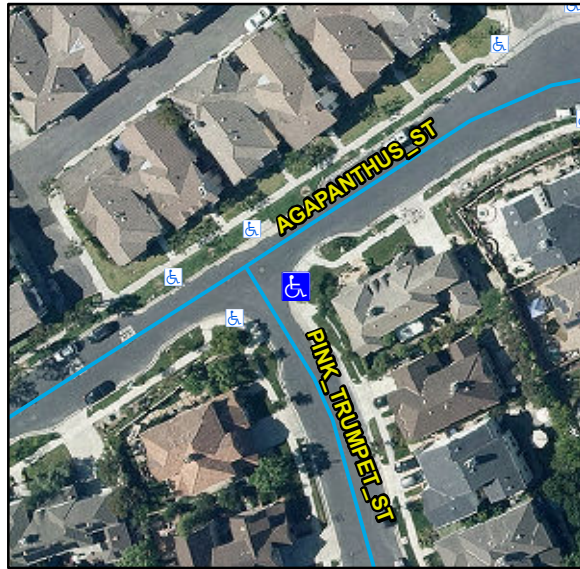
| Compliance | Description | Data | Compliance | Description | Data |
|---|---|---|---|---|---|
| Yes | Ramp Cross Slope LT (%) | 1.8 | No | Ramp Cross Slope RT (%) | 2.3 |

**Remove & Replace Curb Ramp With Two New Directional Ramps or Equivalent.**

**R204.3, R304.5.3, STD 1115**
