# Access Compliance Report Public Rights-of-Way (Curb Ramps)

Main Street: PINK\_TRUMPET\_ST Cross Street: AGAPANTHUS\_ST Location: SW

ADA ID: RPRK211122165423 Ramp Type: Type 4 - Parallel Initial Pass/Fail: Fail Overall Compliance: No Severity Score: 16

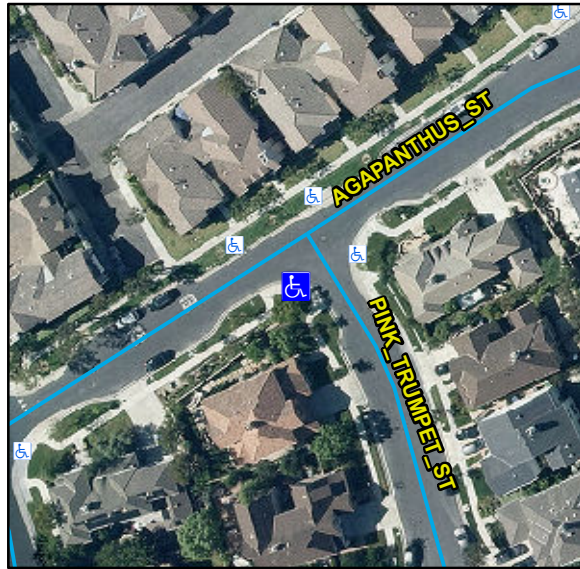
| Compliance | Description | Data | Compliance | Description | Data |
|---|---|---|---|---|---|
| Yes | Ramp Run Slope LT (%) | 7.8 | No | Ramp Run Slope RT (%) | 9.1 |
| No | Ramp Cross Slope LT (%) | 2.2 | Yes | Ramp Cross Slope RT (%) | 1.2 |

**Remove & Replace Curb Ramp With Two New Directional Ramps or Equivalent.**

**R204.3, R304.5.3, R304.3.2, STD 1115**
