# Access Compliance Report Public Rights-of-Way (Curb Ramps)

Main Street: N/A Cross Street: BRIOSO\_ST Location: E

ADA ID: RPRK211123113750 Ramp Type: Type 7 - Directional 2 Initial Pass/Fail: Fail Overall Compliance: No Severity Score: 30

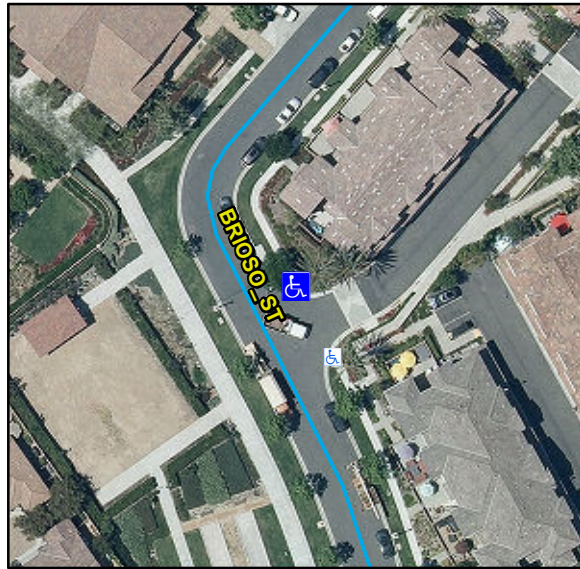
| Compliance | Description | Data | Compliance | Description | Data |
|---|---|---|---|---|---|
| No | Ramp Run Slope (%) | 12.8 | N/A | Flare Slope LT (%) | N/A |

**Remove & Replace Entire Ramp.**

**R304.2.2, STD 1115**
