# Access Compliance Report Public Rights-of-Way (Curb Ramps)

| Main Street: N/A | | Cross Street: BRIOSO_ST | | Location: | E |
| ADA ID: RPRK211123113948 | Ramp Type: Type 7 - Directional 2 | Initial Pass/Fail: Fail | Overall Compliance: No | Severity Score: | 15 |

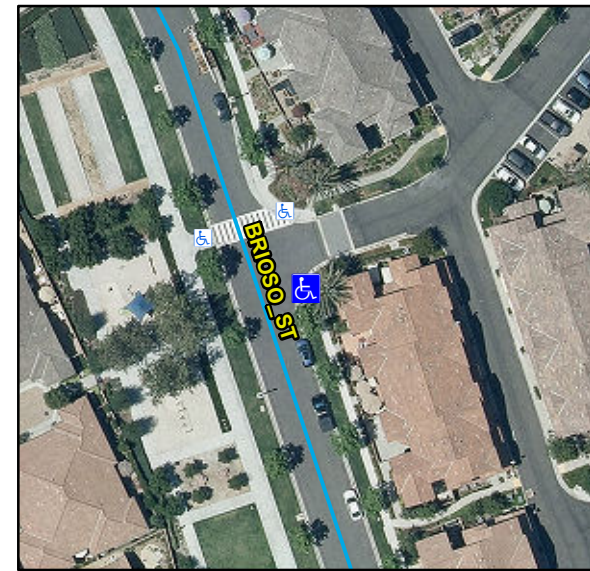
| Compliance | Description | Data | Compliance | Description | Data |
|---|---|---|---|---|---|
| No | Ramp Run Slope (%) | 10.8 | N/A | Flare Slope LT (%) | N/A |

**Remove & Replace Entire Ramp.**

**R304.2.2, STD 1115**

Total Cost: \$ 3080
