# Access Compliance Report Public Rights-of-Way (Curb Ramps)

Main Street: N/A Cross Street: ORTEGA\_HWY Location: NE

ADA ID: RPRK211123122747 Ramp Type: Type 1 - Perpendicular Diagonal Initial Pass/Fail: Pass Overall Compliance: No Severity Score: 5

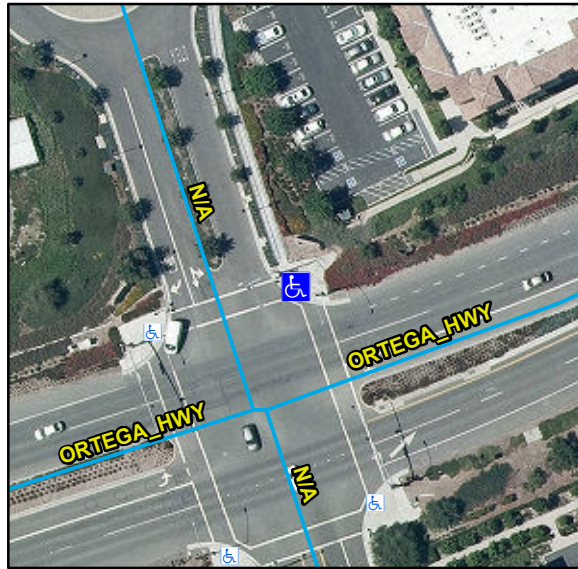
| Compliance | Description | Data | Compliance | Description | Data |
|---|---|---|---|---|---|
| Yes | Gutter Ponding | No | No | Curb Slope | 7 |
| No | Gutter Run Slope (%) | 5.5 | | Road Cross Slope (%) | 0.9 |
| No | Gutter Cross Slope (%) | 5.3 | | | |

Remove & Replace Curb Slope. Remove & Replace Gutter.

R304.2.2, R304.5.4, R304.5.3, STD 1115
