# Access Compliance Report Public Rights-of-Way (Curb Ramps)

Main Street: ORTEGA\_HWY Cross Street: N/A Location: SE

ADA ID: RPRK211123123258 Ramp Type: Type 1 - Perpendicular Diagonal Initial Pass/Fail: Fail Overall Compliance: No Severity Score: 15

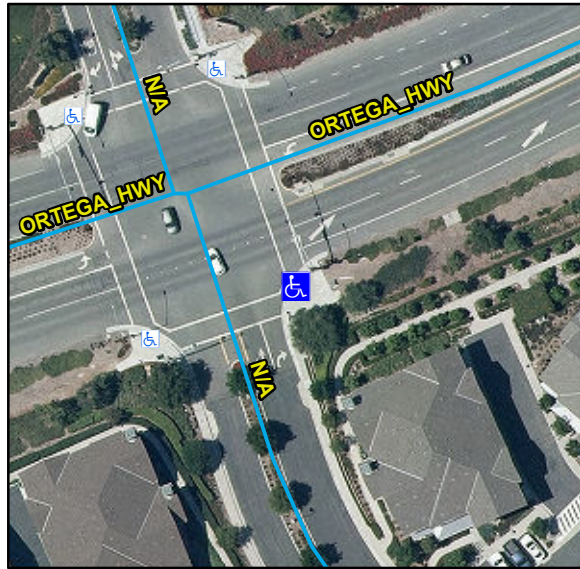
| Compliance | Description | Data | Compliance | Description | Data |
|---|---|---|---|---|---|
| No | Ramp Run Slope (%) | 9.2 | N/A | Flare Slope LT (%) | N/A |

Possible Solutions:

Remove & Replace Curb Ramp With Two New Directional Ramps or Equivalent.

R304.2.2, STD 1115
