# Access Compliance Report Public Rights-of-Way (Curb Ramps)

Main Street: N/A Cross Street: ORTEGA\_HWY Location: SW

ADA ID: RPRK211123123827 Ramp Type: Type 1 - Perpendicular Diagonal Initial Pass/Fail: Fail Overall Compliance: No Severity Score: 30

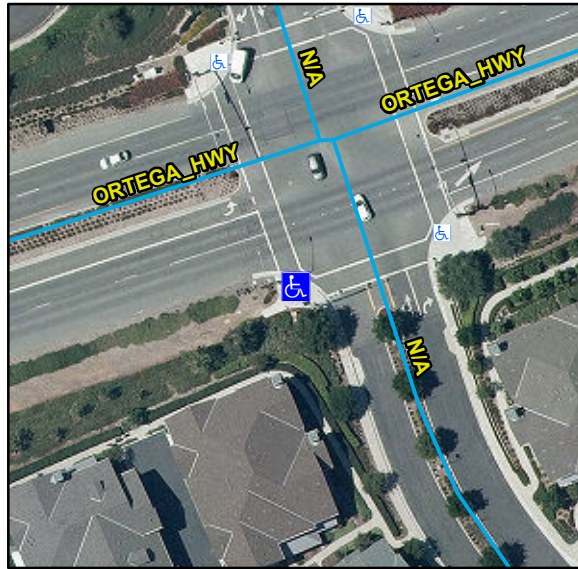
| Compliance | Description | Data | Compliance | Description | Data |
|---|---|---|---|---|---|
| No | Ramp Cross Slope (%) | 7.3 | N/A | Flare Traversable LT | N/A |

Remove & Replace Curb Ramp With Two New Directional Ramps or Equivalent.

R304.2.2, R304.5.3, STD 1115
