# Access Compliance Report Public Rights-of-Way (Curb Ramps)

Main Street: ORTEGA\_HWY Cross Street: N/A Location: NW

ADA ID: RPRK211123124219 Ramp Type: Type 1 - Perpendicular Diagonal Initial Pass/Fail: Fail Overall Compliance: No Severity Score: 16

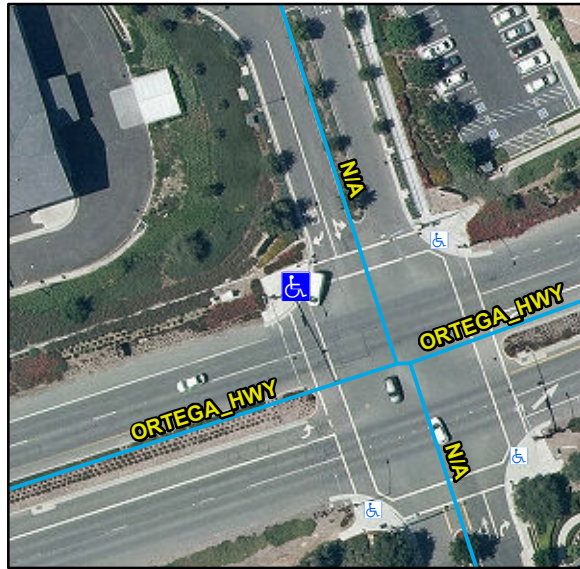
| Compliance | Description | Data | Compliance | Description | Data |
|---|---|---|---|---|---|
| No | Ramp Run Slope (%) | 10 | N/A | Flare Slope LT (%) | N/A |
| No | Ramp Cross Slope (%) | 2.1 | N/A | Flare Traversable LT | N/A |

Remove & Replace Curb Ramp With Two New Directional Ramps or Equivalent.

R304.2.2, R304.5.3, STD 1115
