# Access Compliance Report Public Rights-of-Way (Curb Ramps)

| Main Street: COW_CAMP_RD | | Cross Street: ANTONIO_PKWY | | Location: | SE |
| ADA ID: RPRK211123130034 | Ramp Type: Type 1 - Perpendicular | Initial Pass/Fail: Fail | Overall Compliance: No | Severity Score: | 15 |

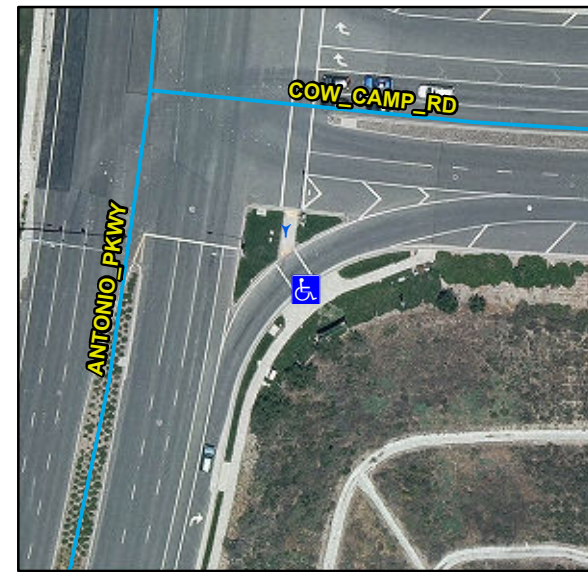
R304.2.2, R304.5.3, STD 1115

| Compliance | Description | Data | Compliance | Description | Data |
|---|---|---|---|---|---|
| No | Ramp Cross Slope (%) | 6.1 | N/A | Flare Traversable LT | N/A |

Remove & Replace Entire Ramp.

Total Cost: \$ 3080
