# Access Compliance Report Public Rights-of-Way (Curb Ramps)

Main Street: ANTONIO\_PKWY Cross Street: COW\_CAMP\_RD Location: NE

ADA ID: RPRK211123130616 Ramp Type: Type 1 - Perpendicular Diagonal Initial Pass/Fail: Fail Overall Compliance: No Severity Score: 2

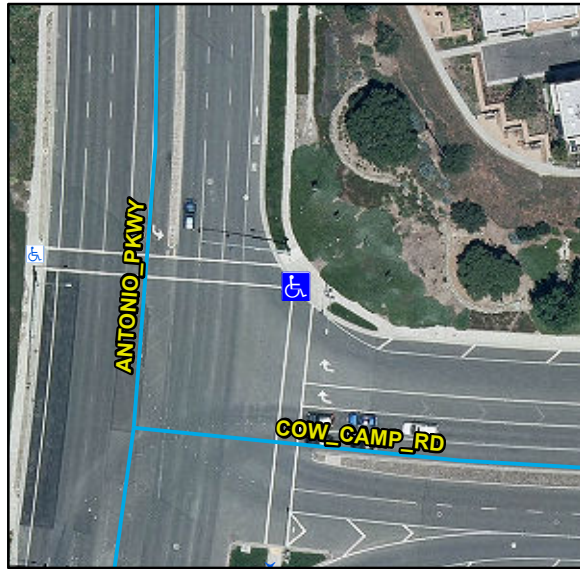
| Compliance | Description | Data | Compliance | Description | Data |
|---|---|---|---|---|---|
| No | Ramp Cross Slope (%) | 2.2 | N/A | Flare Traversable LT | N/A |
| N/A | Gutter Ponding | N/A | No | Curb Slope | 14.7 |

Remove & Replace Curb Ramp With Two New Directional Ramps or Equivalent.

R304.2.2, R304.5.3, STD 1115
